Dash Warning Light plus

VCDS Scan results

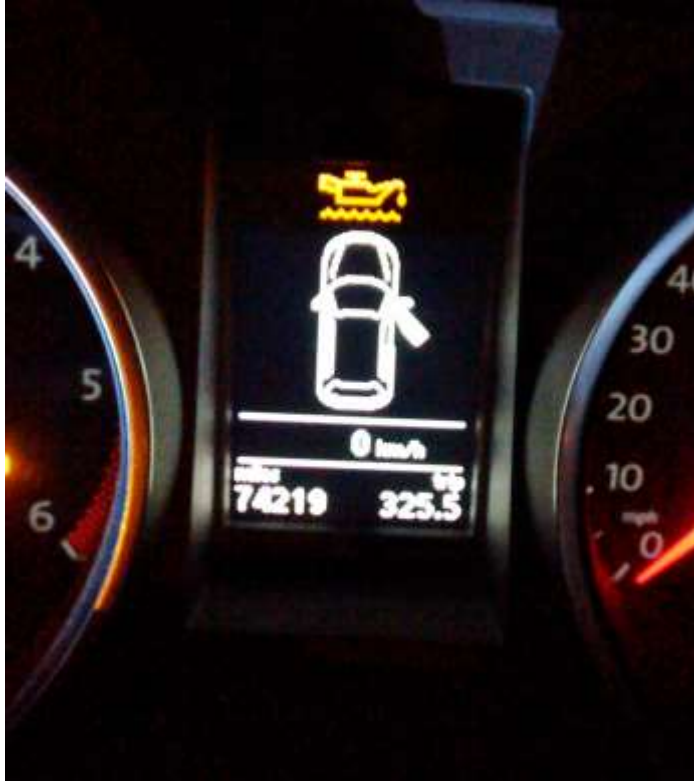
Address 17: Instruments Labels: 5K0-920-xxx-17.clb-SR11
Control Module Part Number: 5K0 920 972 A HW: 5K0 920 972 A
Component and/or Version: KOMBI H03 0607
Software Coding: 470B00
Work Shop Code: WSC 01357 011 00200
ASAM Dataset: EV_Kombi_UDS_VDD_RM09 A04114 (VW36)
ROD: EV_Kombi_UDS_VDD_RM09_004_VW36.rod
VCID: 2E05F3F0D09D2DB7D04-807A

3 Faults Found:

1416448 - Oil Level Thermal Sensor

B1041 29 [008] - Signal Implausible
Intermittent - Confirmed - Tested Since Memory Clear

9453842 - Oil Level Thermal Sensor

B1041 35 [009] - Signal high time > maximum
Confirmed - Tested Since Memory Clear

Fault only in Instruments Module.

No Faults in Engine Module

13639427 - Please Check Fault Codes in Engine Control Module

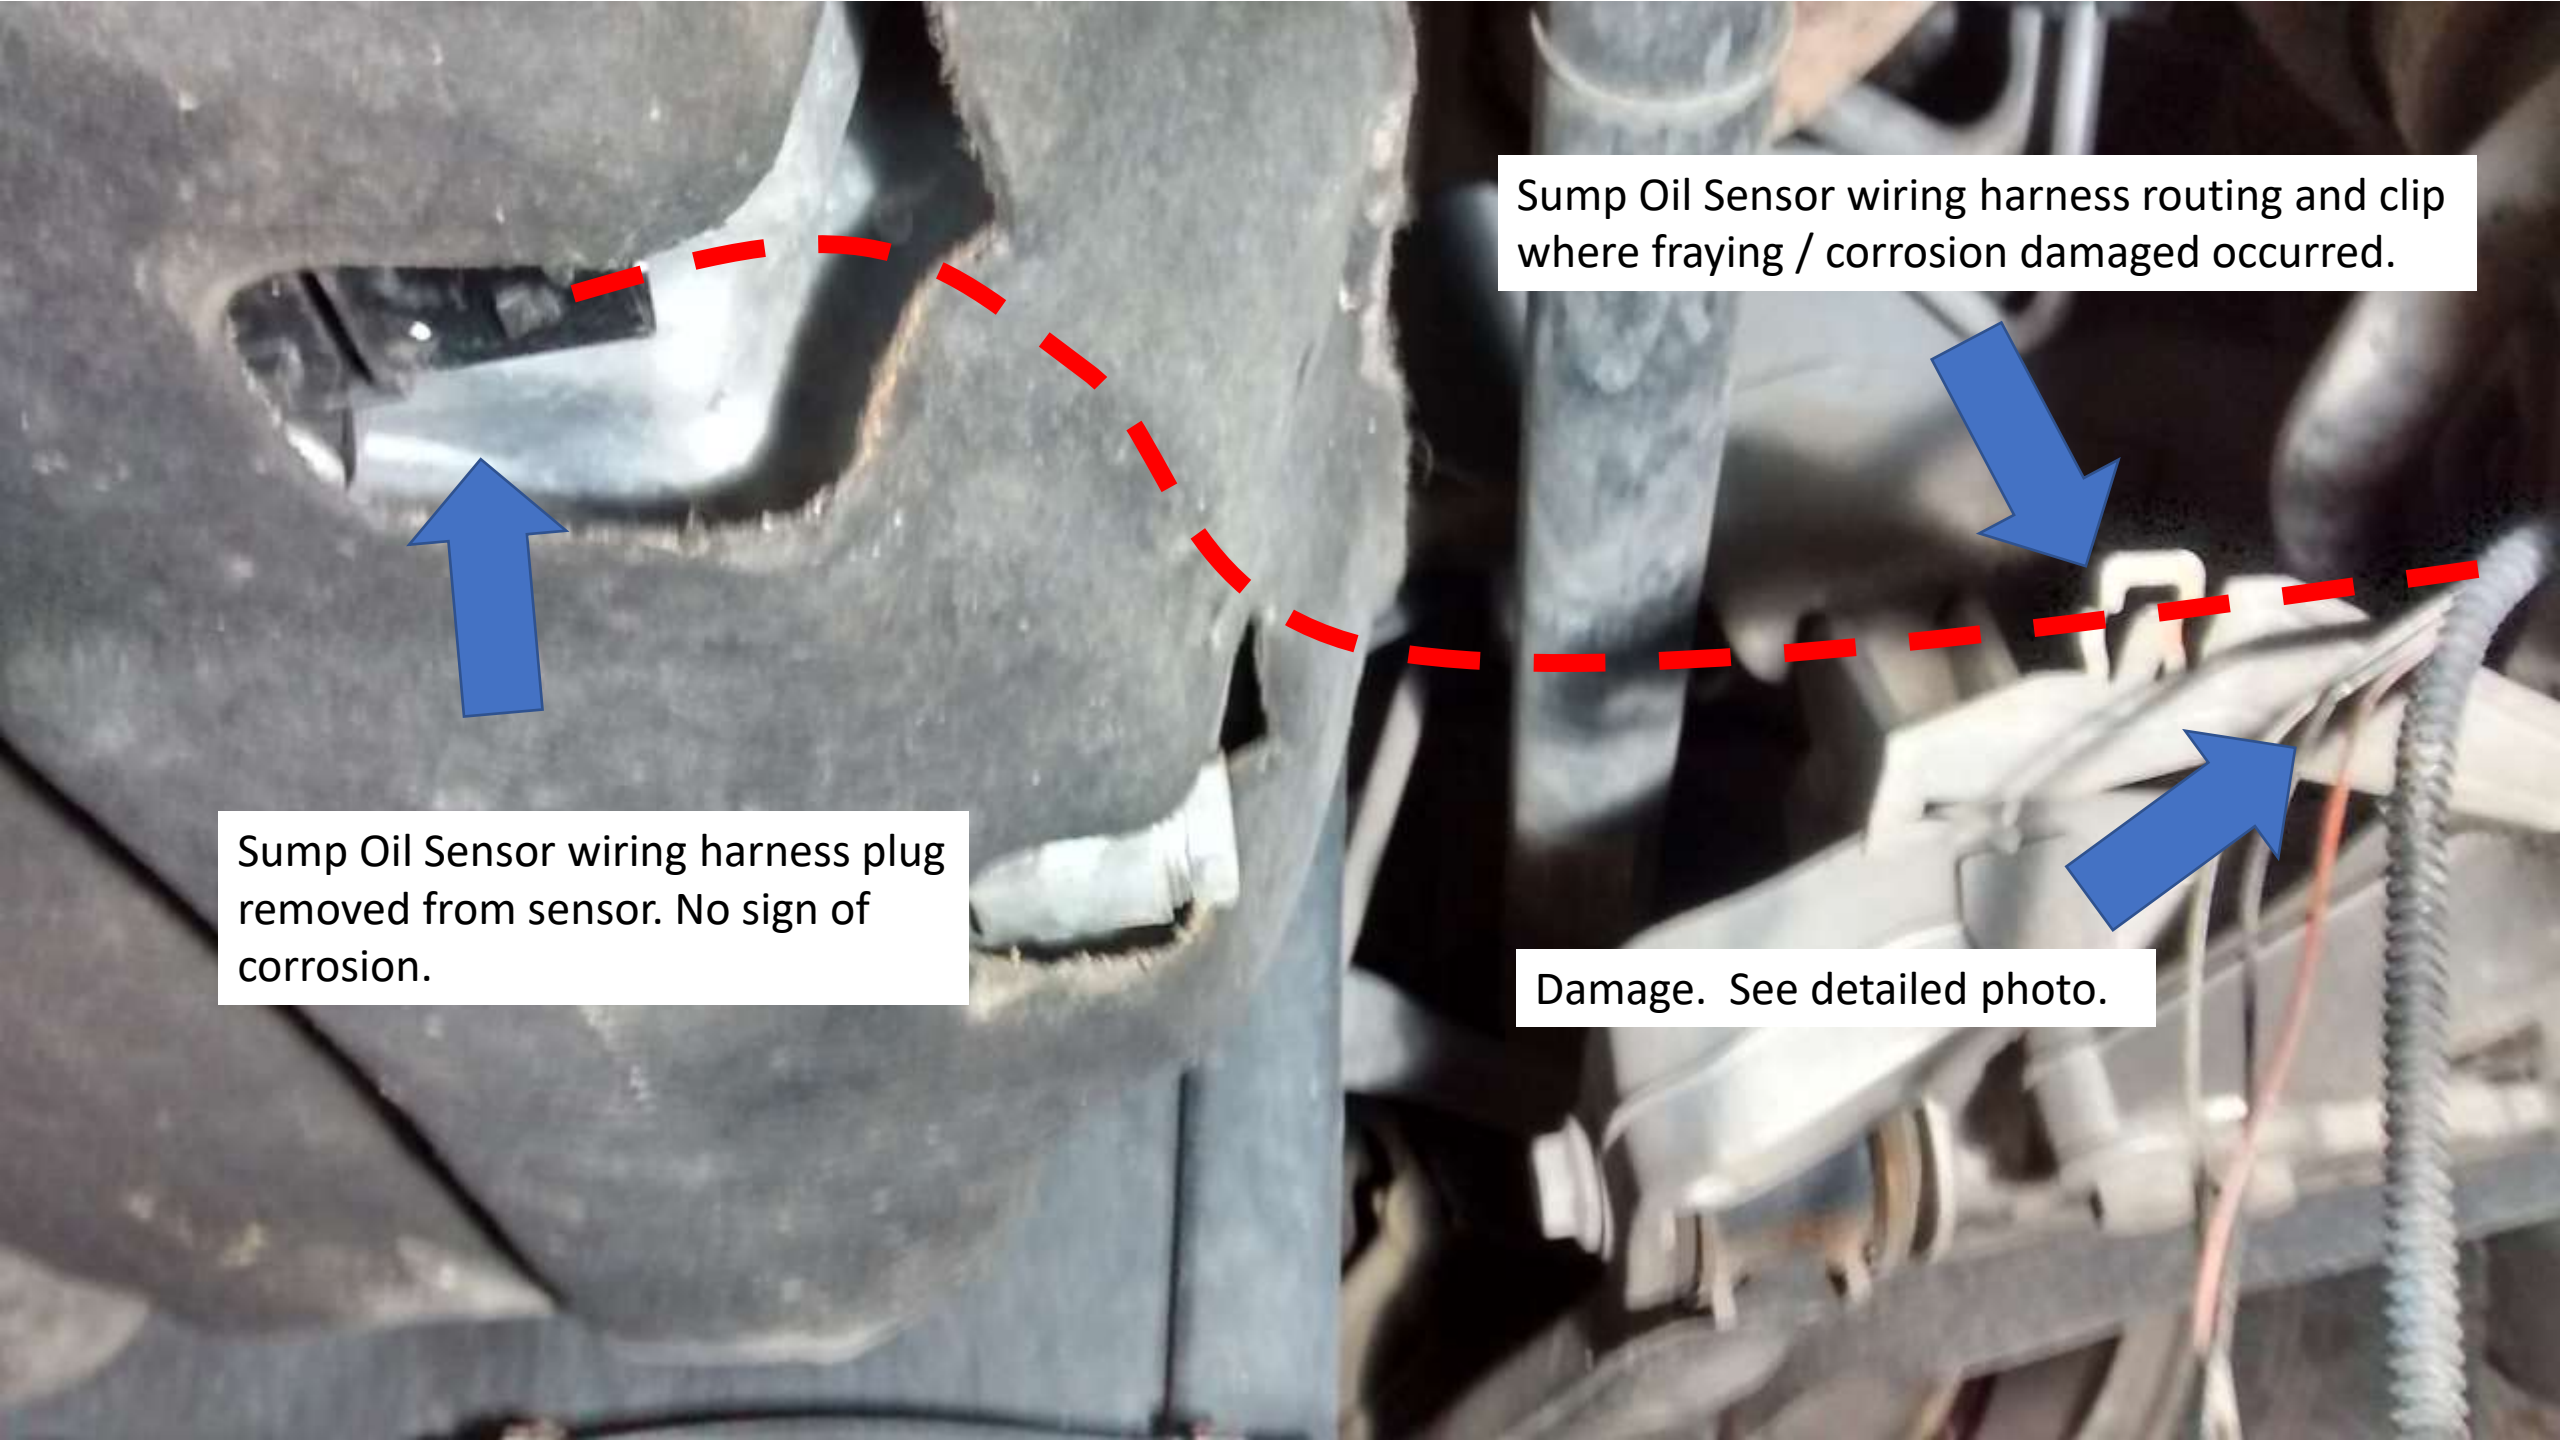
Sump Oil Sensor wiring harness routing and clip where fraying / corrosion damaged occurred.

Sump Oil Sensor wiring harness plug removed from sensor. No sign of corrosion.

Damage. See detailed photo.

Repaired cables, reconnected to sensor and cleared fault codes now works fine.

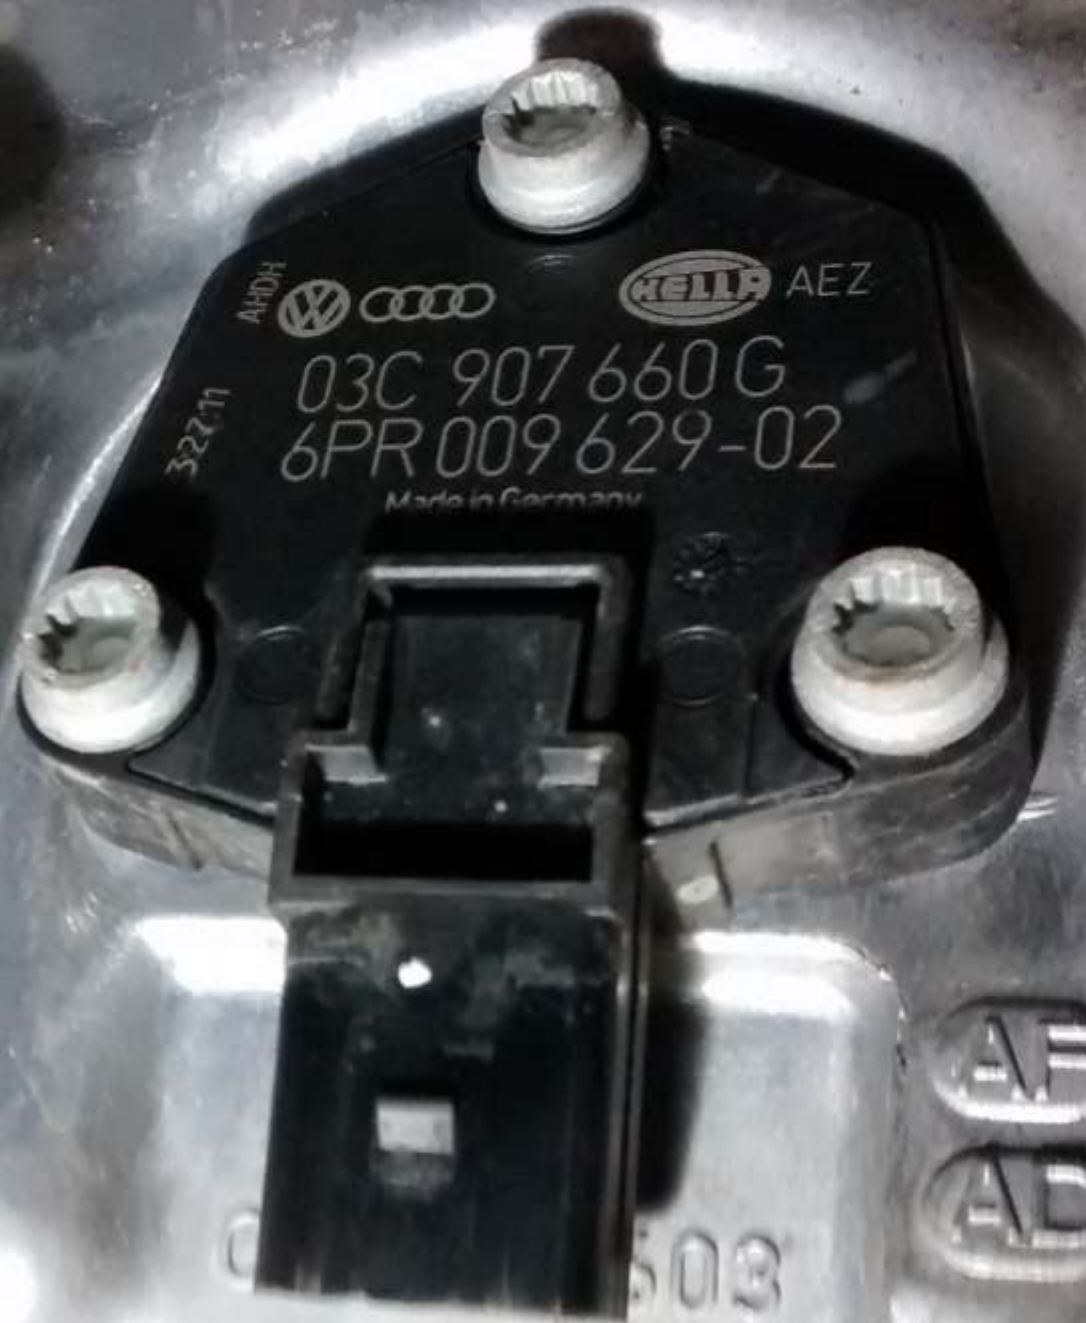
Sump Oil Sensor in-situ picture.
Insulation removed

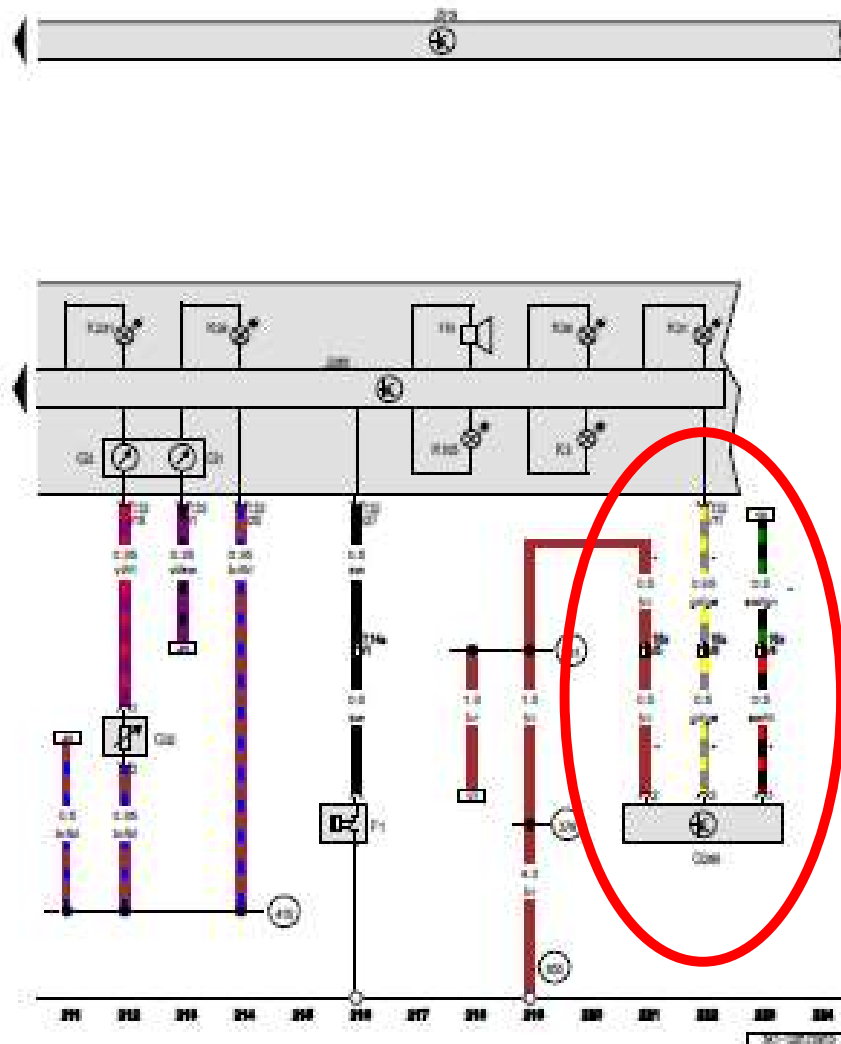
Oil pressure switch, Fuel gauge, Coolant temperature gauge, Coolant shortage indicator sender, Oil level and oil temperature sender, Control unit in dash panel insert, Glow period warning lamp, Diesel particulate filter warning lamp

- F1 -Oil pressure switch
- G1 -Fuel gauge
- G3 -Coolant temperature gauge
- G92 -Coolant shortage indicator sender
- G268 -Oil level and oil temperature sender**
- H3 -Buzzer and gong
- J285 -Control unit in dash panel insert
- J519 -Onboard supply control unit
- K3 -Oil pressure warning lamp
- K29 -Glow period warning lamp
- K31 -Cruise control system warning lamp
- K38 -Oil level warning lamp
- K105 -Reserve fuel warning lamp
- K231 -Diesel particulate filter warning lamp
- T6z -6-pin connector, near left headlight
- T14a -14-pin connector, near battery
- T32 -32-pin connector
- 376 -Earth connection 11, in main wiring harness
